# DK Global Fashion Wear Ltd.

17 July 2023

## Structural Inspection Report

Observations & Actions

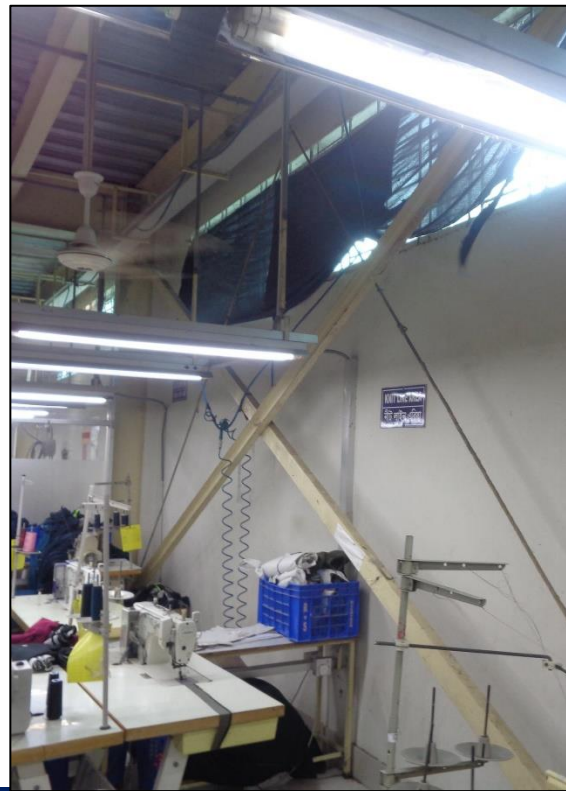
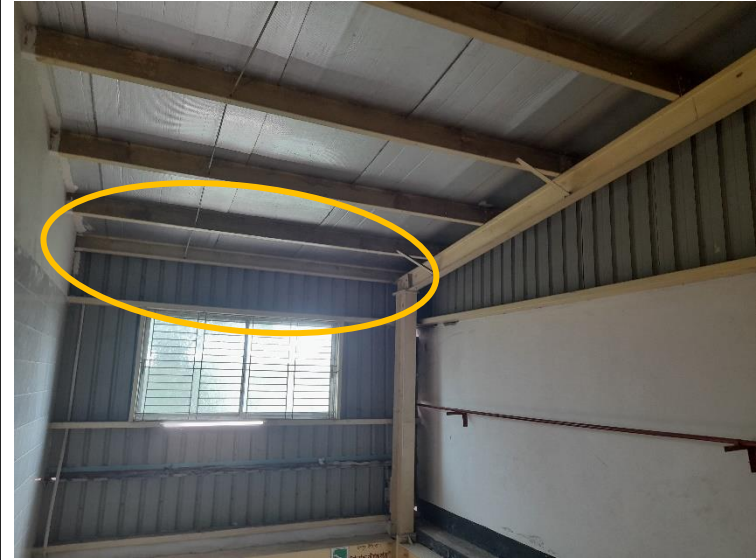
Compression strut missing in gable frame

Roof and wall bracing were provided at some location. However, compression strut was missing in gable frames to transfer the lateral load therefore lateral stability system of the shed is apparently incomplete. Building engineer is required to check the lateral stability system of the structure and suggest necessary remedial actions accordingly.

- Building engineer is required to check the lateral stability of the structure and suggest necessary remedial actions accordingly.

- Implement remediation work where required.

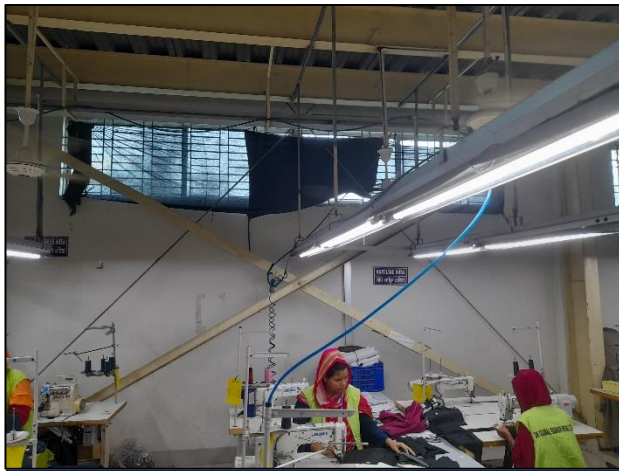
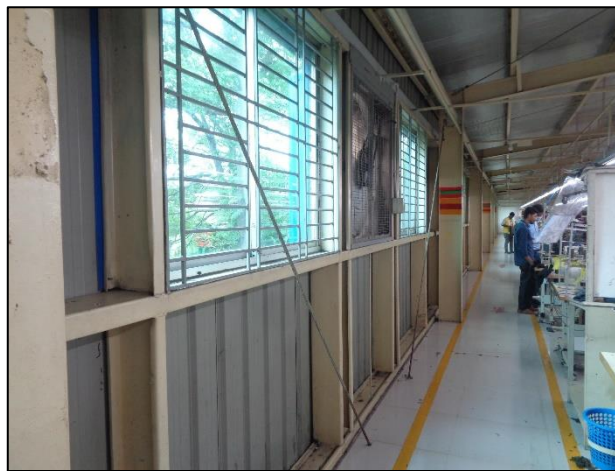
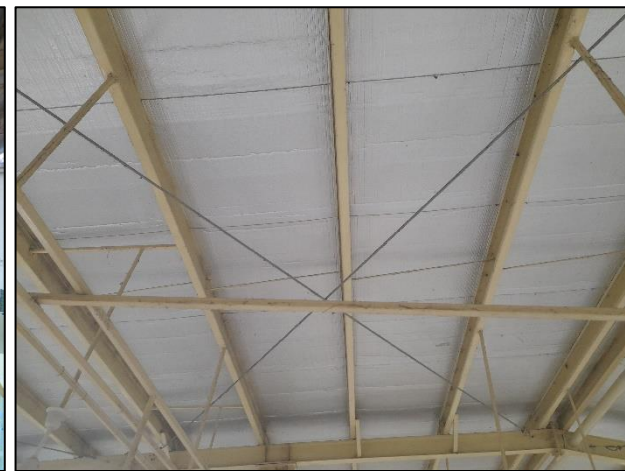
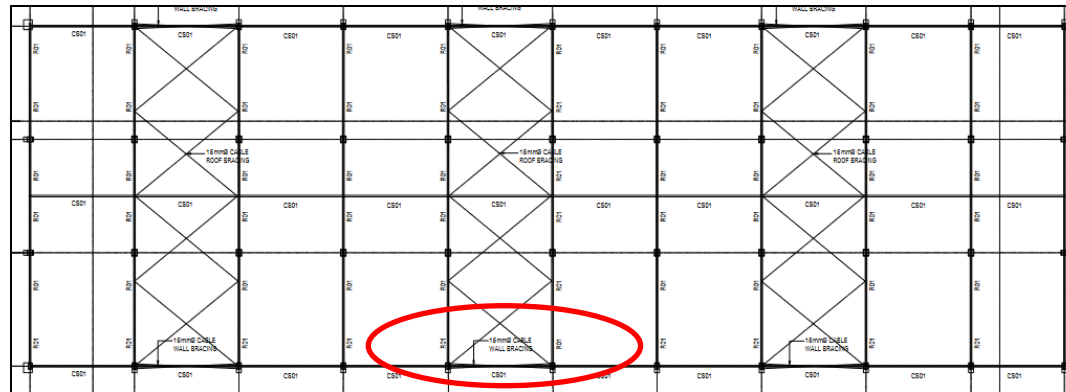
In bracing layout plan, only horizontal and vertical cable bracing was shown. However, no information was available regarding vertical angle bracing on ground floor. In addition, elevation view and connection details of bracings were also not present in the as-built structural drawing. The building engineer is required to survey the whole structures and prepare accurate as-built drawings accordingly.

- The building engineer is required to survey the structure and prepare accurate as-built drawing.

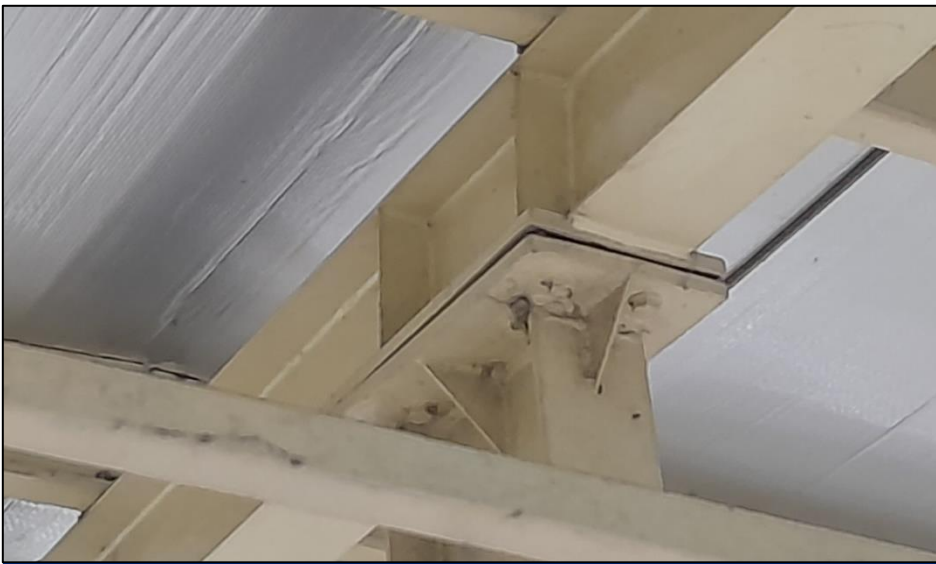
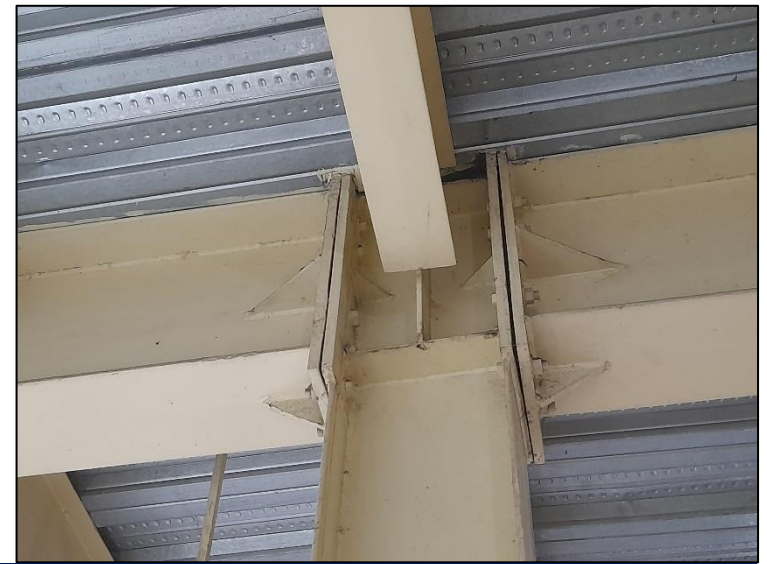
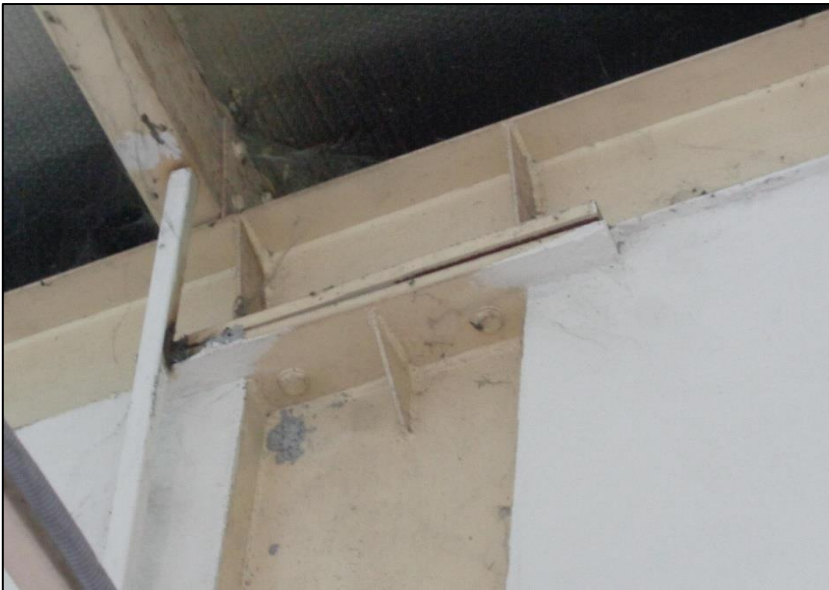
Significant gap in steel connection plates in different location

Significant gap in steel connection plates of rafter & column was found at different locations of the structure. Building engineer is required to survey the whole structure & identify the locations of the connection gaps. Factory engineer is also required to assess the reason of connection gap & provide proper remediation. Factory is required to follow recommendation of remediation suggested by the engineer.

- Building engineer is required to repair the gap in connections with a suitable method.

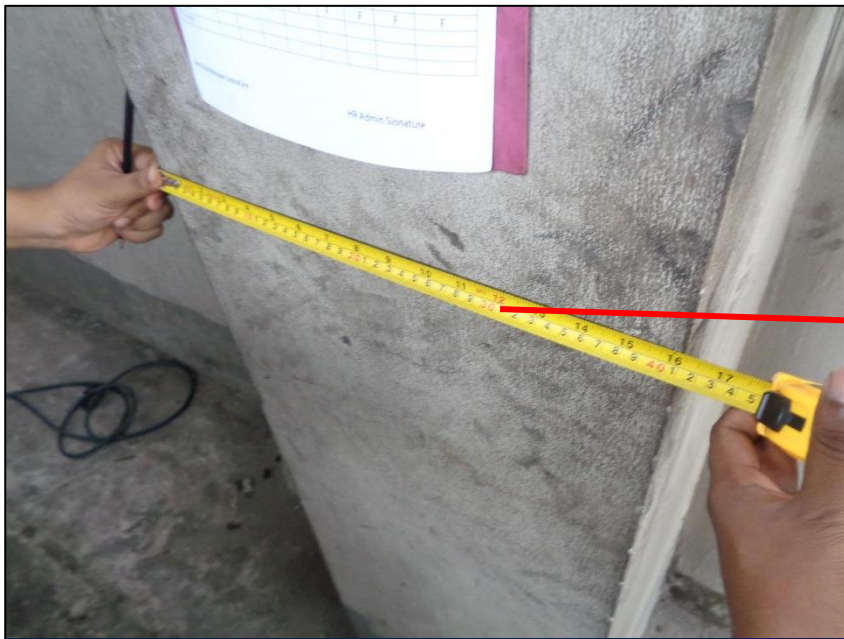
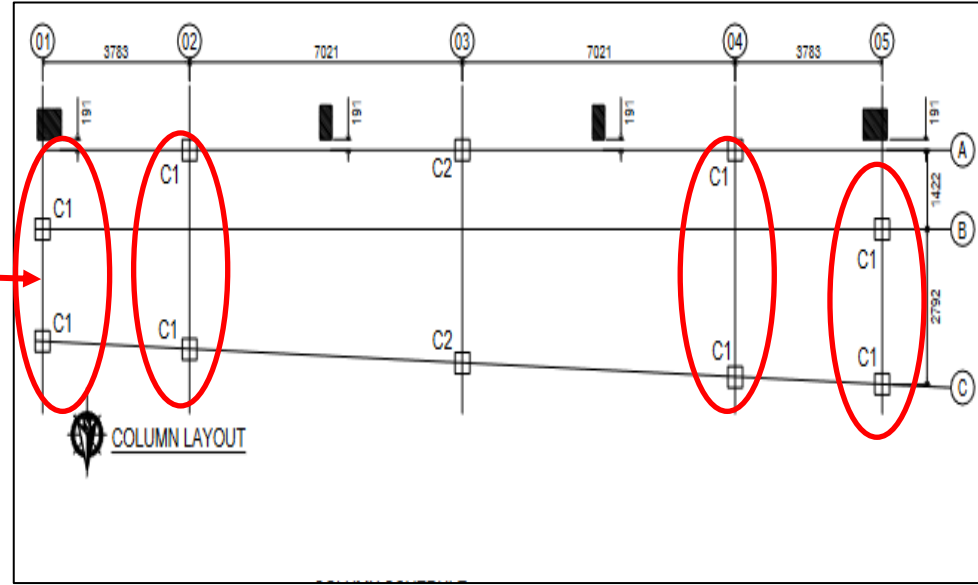
C6 column was measured 450 mm instead of 500 mm

In column schedule C1 column dimension was shown 425X425 mm. However, during inspection, all C1 columns were measured 375X375 mm. The building engineer is required to survey the whole structures and prepare accurate as-built drawings accordingly.

- The building engineer is required to survey the structure and prepare accurate as-built drawing.

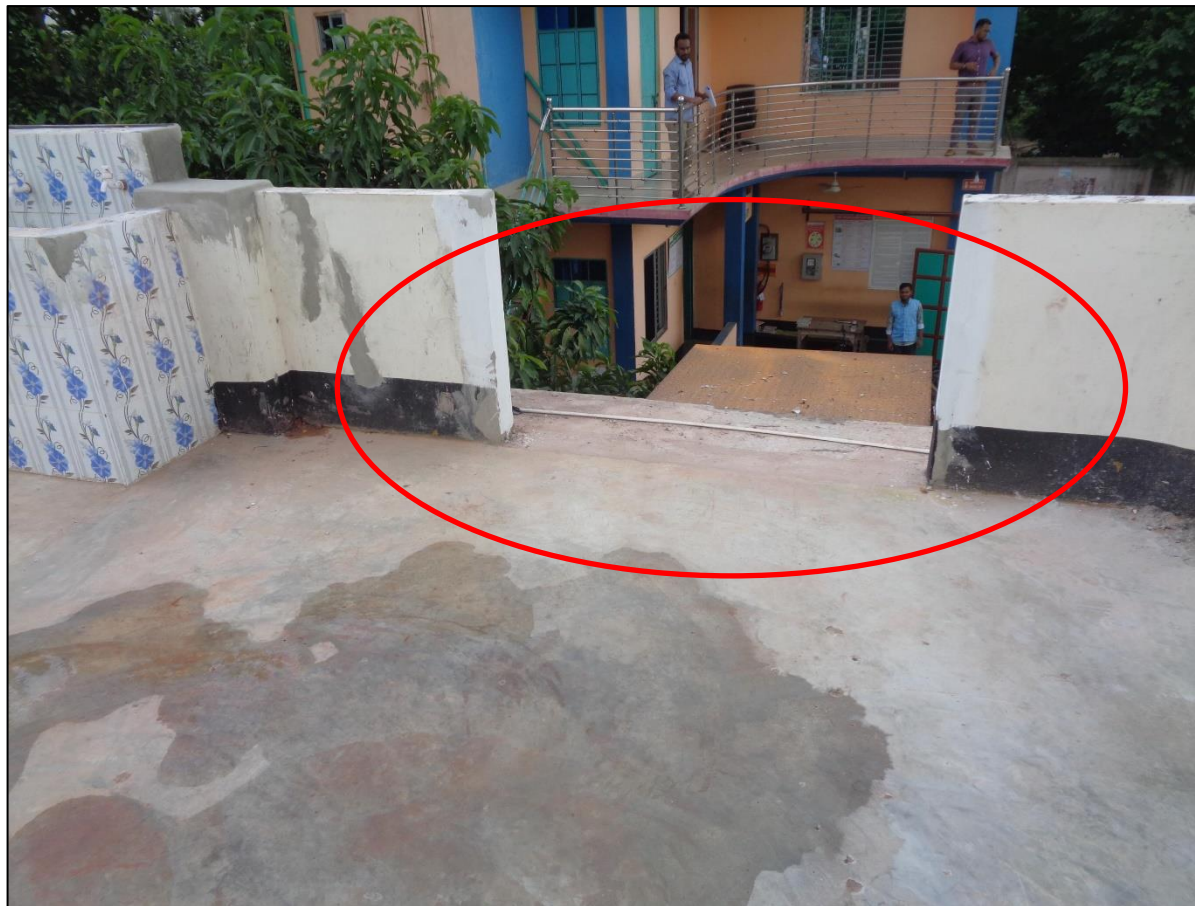
Opening at parapet wall

There were an opening area in parapet wall on canteen building roof which may cause falling hazard. The factory is required to provide adequate barrier/railing/walls on the opening area to protect possible falling hazard.

- Building engineer is required to provide adequate barrier/walls on the opening area of the roof to protect possible falling hazard.

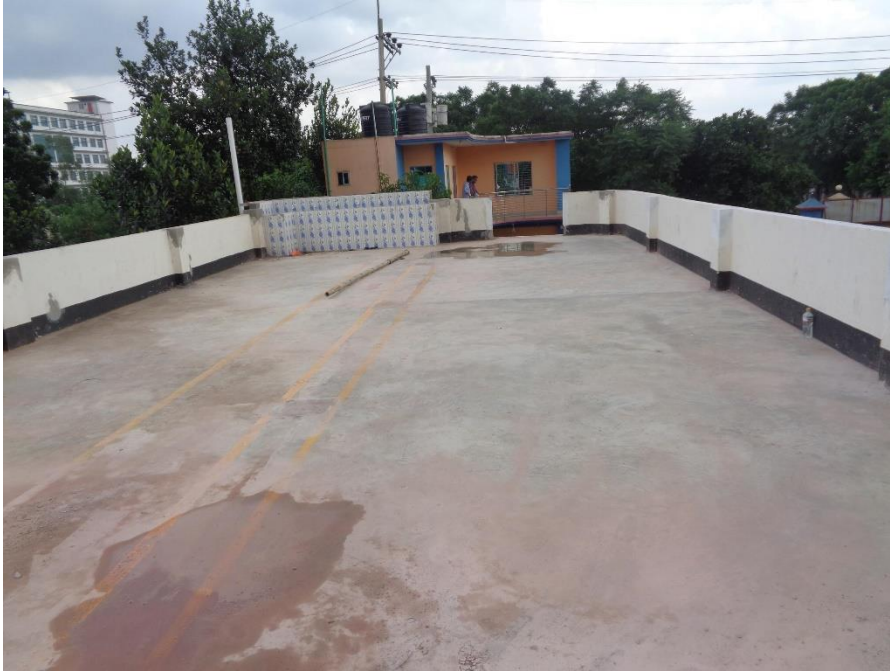
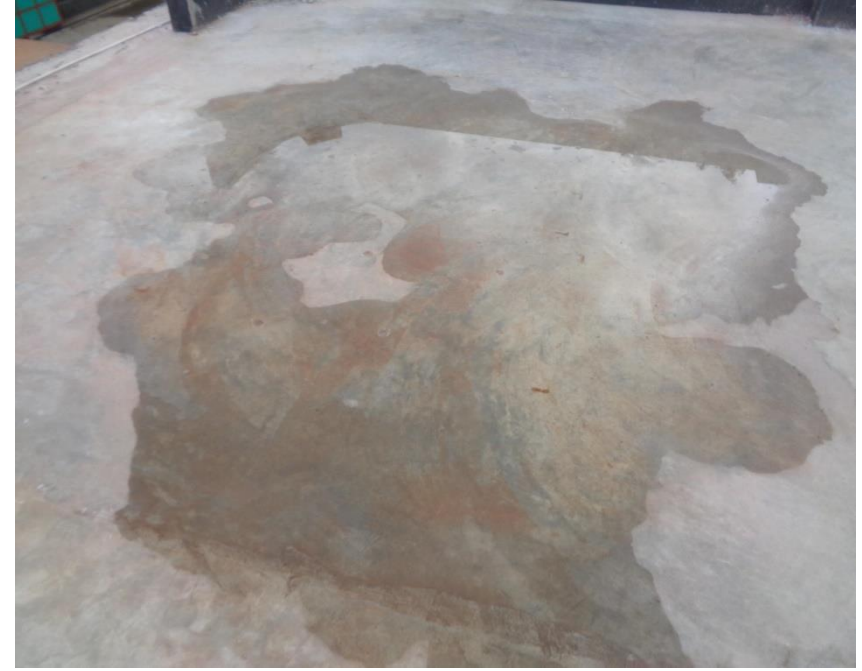
MCAC roof of Canteen Building

Water proofing was not applied on the roof. The roof is made of brick aggregate concrete. The building engineer is required to apply the water proofing layer on the current roof with proper slope.

- The building engineer is required to apply the water proofing layer on the current roof with proper slope.

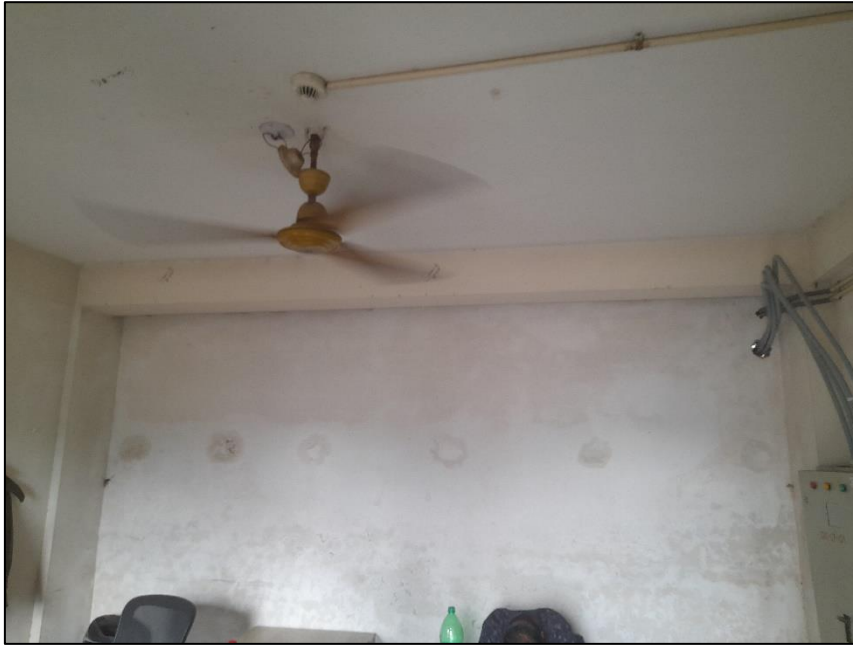
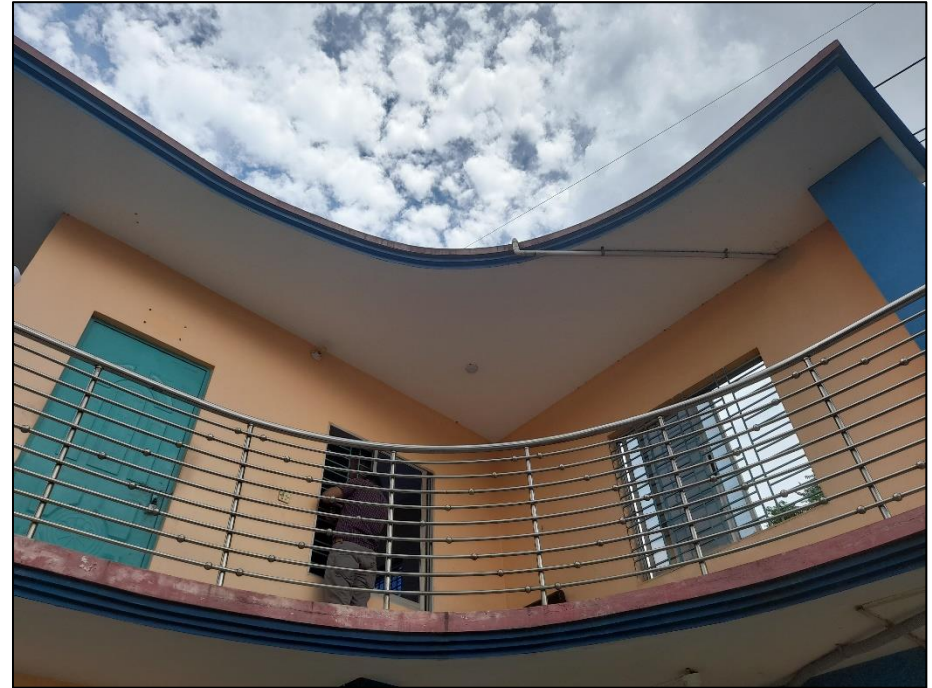
Security Guard Room

As per BNBC, every building or structure designed shall have its design documents prepared in accordance with the provision of Section 1.9.1. The design document shall include a design report, and a set of structural drawings, which shall be prepared in compliance with section 1.9.1.1 and section 1.9.1.2, part-6 of BNBC. At the time of inspection, no as-built drawings and design documents were available which are required to be prepared in compliance with section 1.9.1.1 (part-6, BNBC).

- Building engineer is required to prepare the design documents including a design report, and a set of structural drawings in compliance with section 1.9.1.1 and section 1.9.1.2, part-6 of BNBC and submit it to RSC for review.

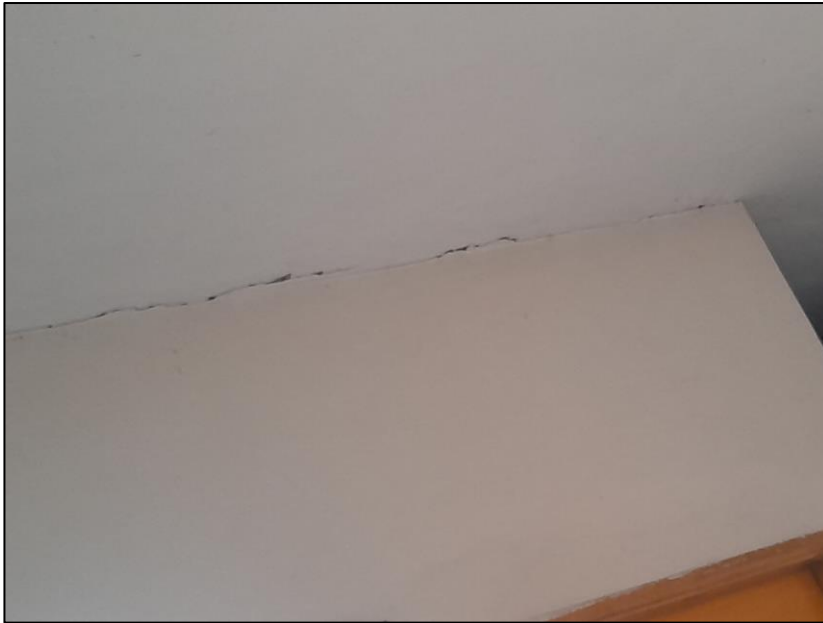
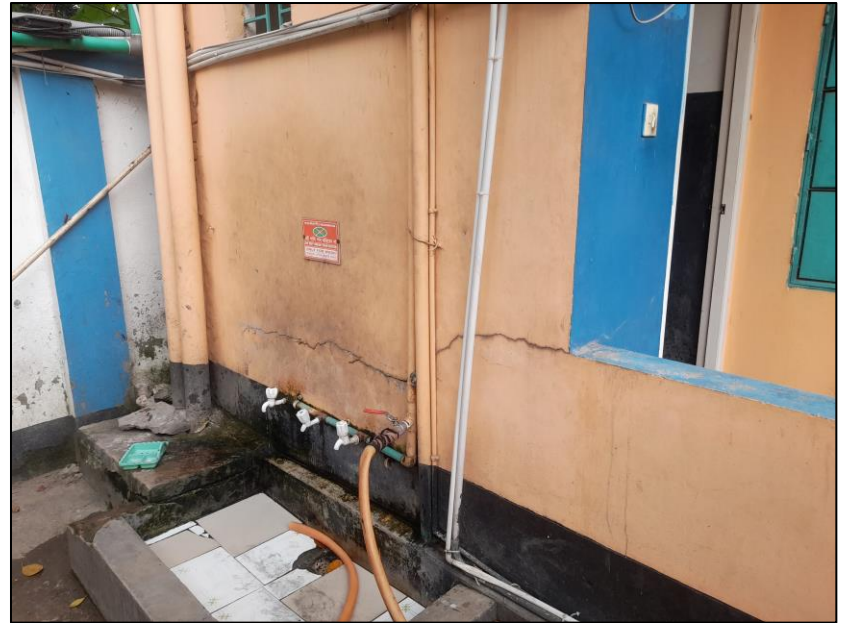
Cracks on masonry walls

Building engineer is required to investigate the cause of wall cracks and repair with a suitable method.

- Building engineer is required to investigate the cause of wall cracks and repair with a suitable method.
