INITIAL FIRE SAFETY INSPECTION REPORT

DK Global Fashion Wear Ltd.

RSC ID: 24677

Date: 17 July 2023

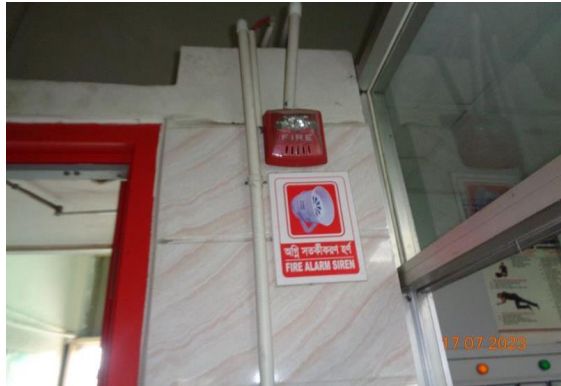
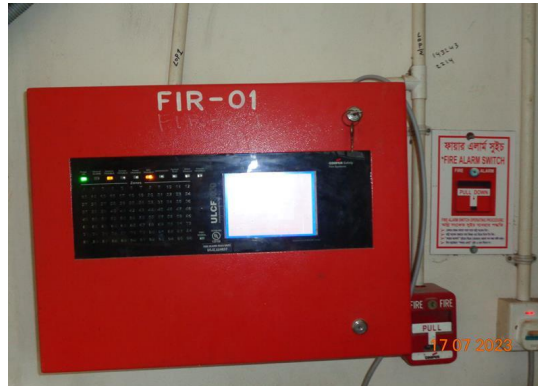
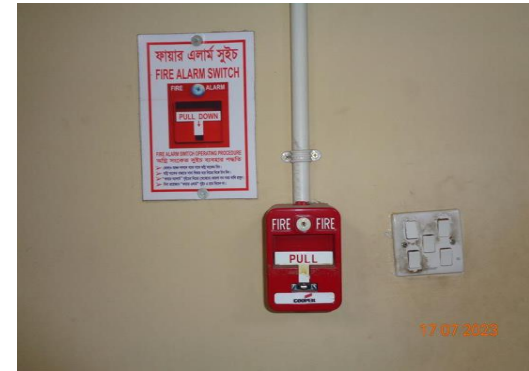
Current System Overview: There is an automatic fire alarm and detection system control panel (**Brand: COOPER**)(**Model: ULCF3000**) found installed in the factory during inspection. It consisted of call points & mixture of smoke and heat detectors, notification appliances and control modules. Functional test was not conducted during the inspection. Proposed design of fire alarm and detection system was not found available. Regular inspection, testing and maintenance records of the fire alarm system were not found. Factory shall provide the proposed designs to RSC for review.

Type of System	Addressable	
Fire Panel Location	Security & Fire Control Room	
Visible Notification Per NFPA 72	No	Not verified
Audible Notification Per NFPA 72	No	Not verified
Alarm Annunciation	Yes	
ITM per NFPA 72	No	
Functional Test Conducted	No	
Type of Detector	Addressable

Smoke Detection Per NFPA 72	No	Not verified.
-----------------------------	----	---------------

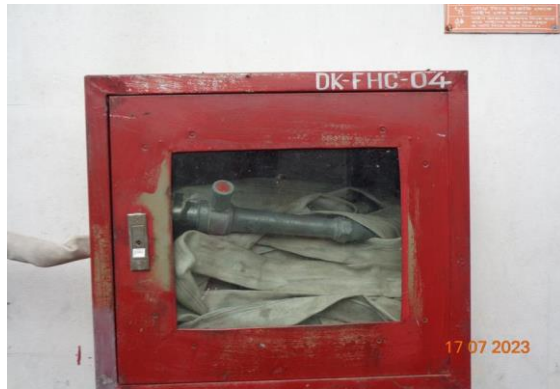
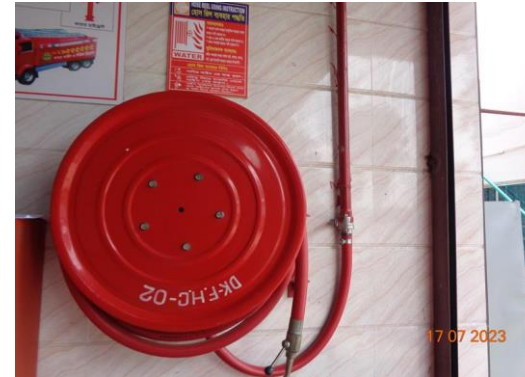
Current System Overview: The highest occupiable floor level from finished ground level is 15 ft. Based on the height of the highest occupiable floor, standpipe system is not required. 1 inch hose reel is provided. Records of regular testing or maintenance of the standpipe system were not provided in accordance with NFPA 25.

Standpipe System Required	No	
Type of System Installed	1" Hose Reel	
Hose Connection Locations	Near Exit

ITM Per NFPA 25	No	
Comments

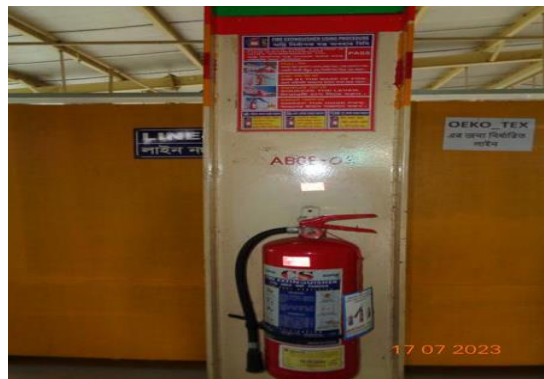
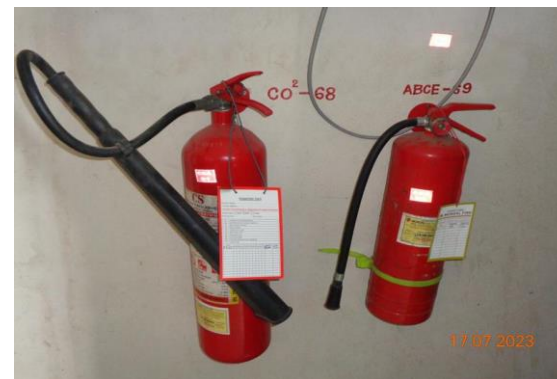
Current System Overview: Portable fire extinguishers, consisting of a mix of CO2 and dry chemical were provided throughout the building. Inspection tags show recent and up-to-date inspections. Records of regular testing or maintenance of the portable fire extinguishers were provided as per NFPA 10.

Types Provided	Dry Powder, CO2 and Foam	
Adequate Number/Spacing	Yes	
ITM Per NFPA 10	Yes

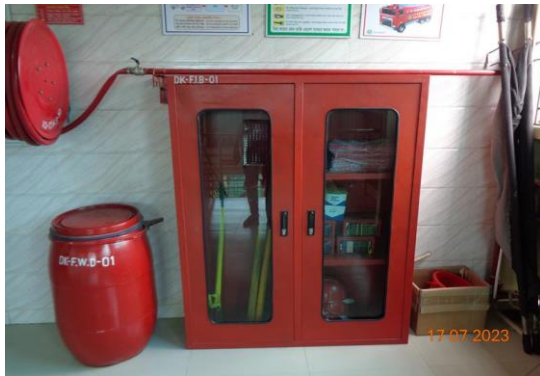
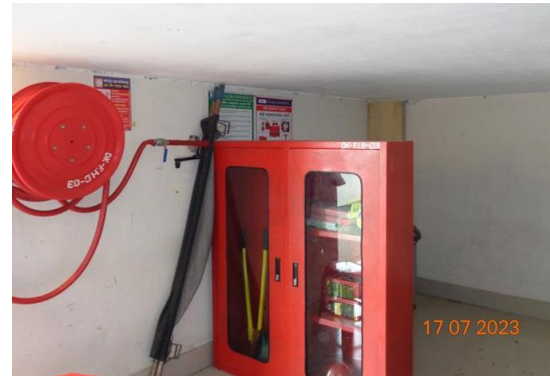
Current System Overview: Factory had firefighting equipment staged inside of production floor in this factory Building. Types of manual firefighting equipment provided included: buckets, escape hoods, bolt/lock cutters, shovels, stretchers and personal protection equipment.

Types Provided	Buckets, escape hoods, bolt/lock cutters, shovels and personal protection equipment.	
Location of Equipment	Staircase

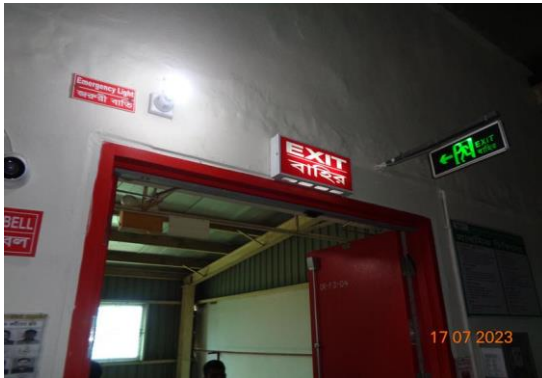
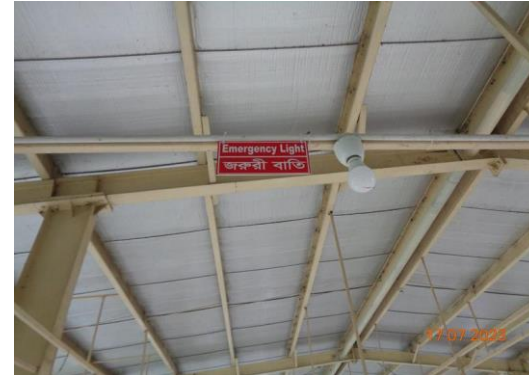
Overview: Emergency lighting appliances were located inside the production floor and exit stairs. There were multiple CFL lights that had an alternate “Instant Power Supply” (IPS). Illuminated exit signs, located at exits. The factory management reported that these are all serviced by normal electricity as well as by multiple “Instant Power Supply” (IPS) units. Record of regular testing or maintenance of the emergency lighting system is not maintained in accordance with Accord standard.

Exits and Exit Access Properly Marked with Exit Signage	Yes	
Emergency Power	Yes	
Adequate Emergency Lighting for Exits & Exit Access	Yes	
Adequate Inspection / Testing (RSC Technical Guideline (Standard). 10.12)	No

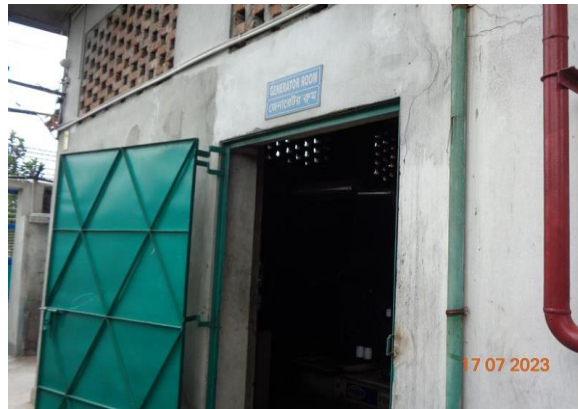
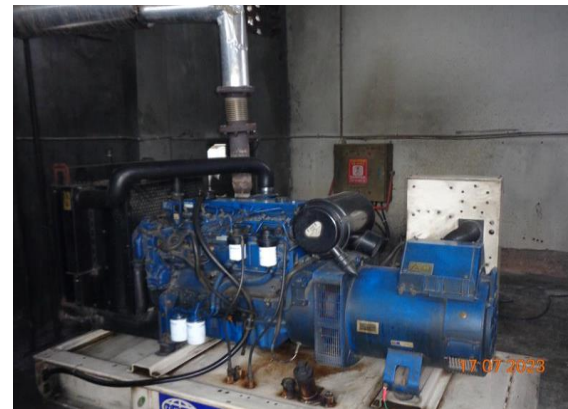
The Desiel generator having capacity 150 KVA which is installed at Utility Building.

Location(s)	Building-2 (Utility Building)	
Fire Rated Separation	No	
Generator Area Free of Additional Fuels	Yes

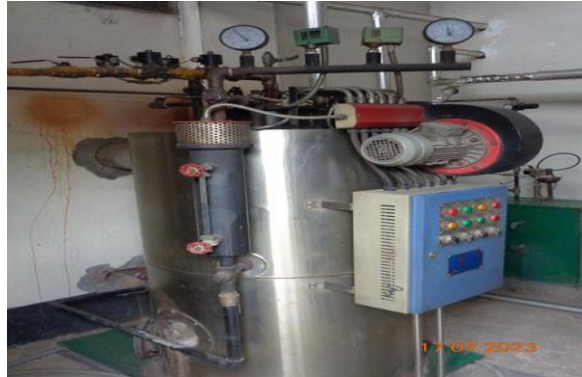
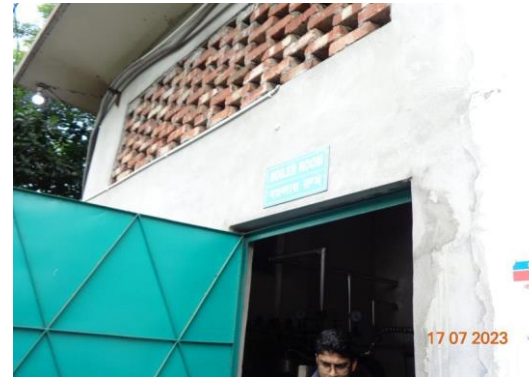
One(1) Boiler is located at Utility Building.

Location(s)	Building-2 (Utility Building)	
Fire Rated Separation (RSC Technical Guideline (Standard) 3.4.2.1.2)	No

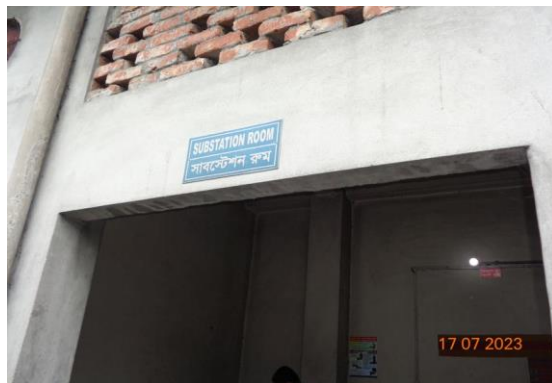
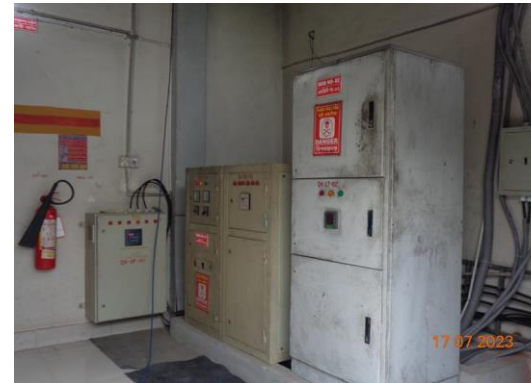
The transformer is outside Pole mounted.

Location(s)	Outside Pole Mounted	
Fire Rated Separation (RSC Technical Guideline (Standard) 3.4.2.1.4)	N/A

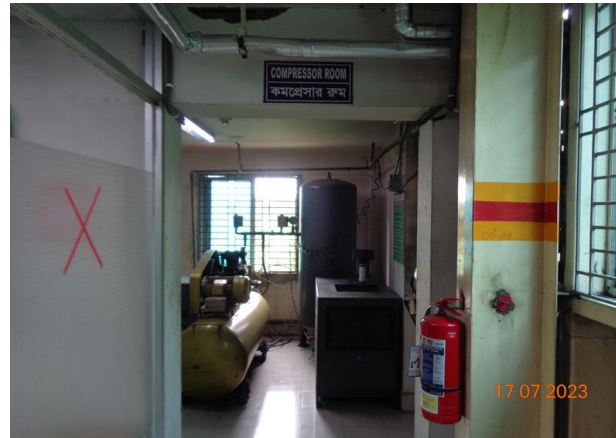
Two compressors are located at Utility Building

Location(s)	Building-2 (Utility Building)	
Fire Rated Separation (RSC Technical Guideline (Standard) 3.4.2.1.2)	No

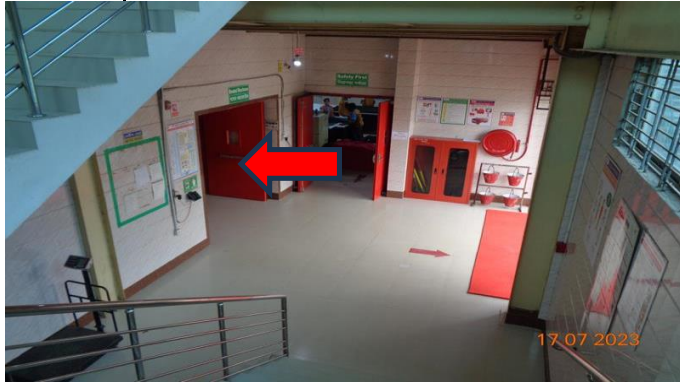
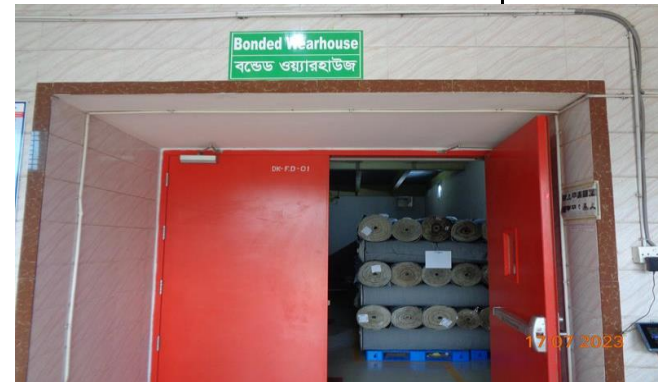
Warehouse store were located at ground floor of Building-1 (Production Building)

Fire Rated Separation (RSC Technical Guideline (Standard) V1.0-3.4.2.1.5)	No	
Open to Factory Floors?	Yes

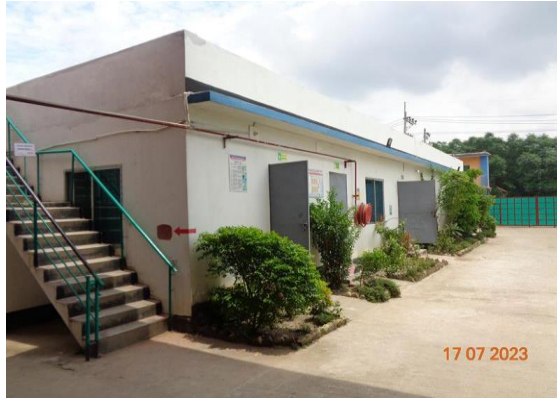
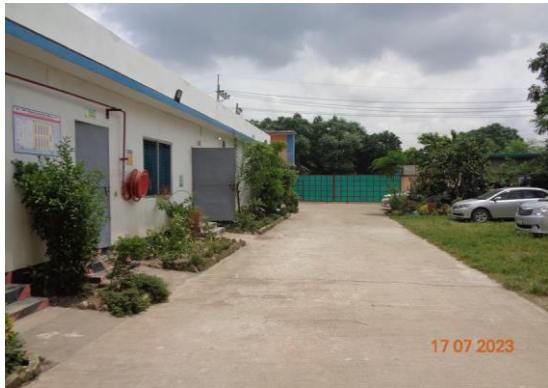
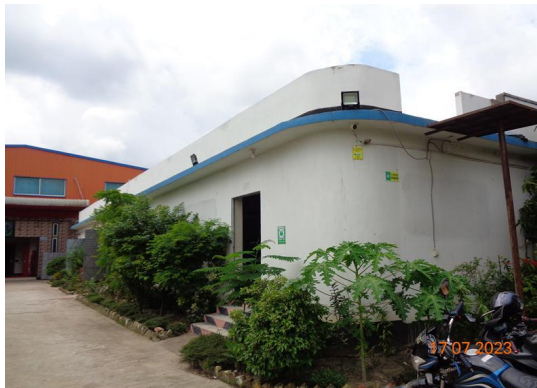
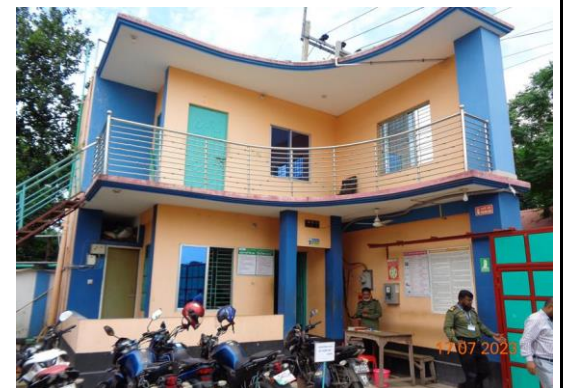
Apart from the main production building the factory complex also contains THREE(3) ancillary buildings.

1. Building-2 (Utility Building): It is a TWO(2) storied RCC Building. (Construction time: October 2016 to June 2018)
2. Canteen Building : It is a single story RCC Building (Construction time: October 2016 to April 2020).
3. Security Building : It is a TWO(2) storied RCC Building. (Construction time: October 2016 to June 2018).

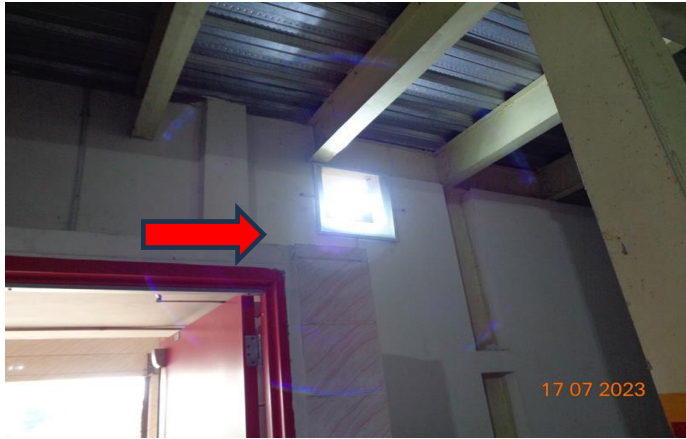
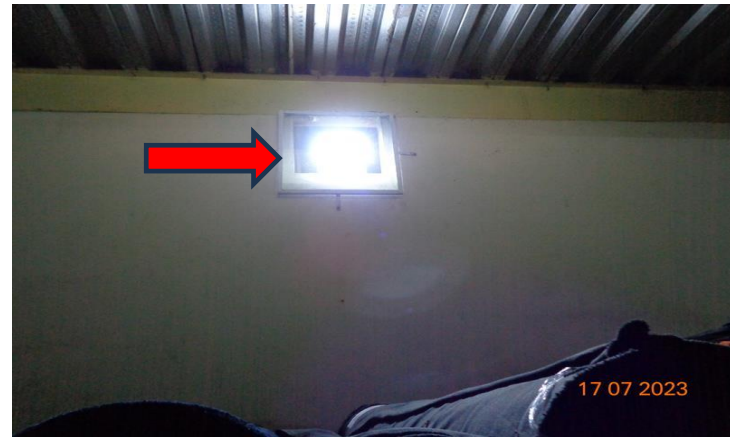
SI No.	Category	Findings	Required Action	Remediation Time Frame
F-1	Fire Rated Construction	Proper certification was not available for fire rated doors installed in the factory.	Submit proper certifications for installed fire doors during inspection for approval. If not available or certification is not approved, install new, properly certified fire rated doors in accordance with RSC Technical Guideline.	Within 3 Months
F-2	Fire Rated Construction	Rooms used for storage of combustible materials are not separated from the surrounding occupancy/areas & floors. Location: Ground Floor	Rooms used for storage of combustible materials shall be separated from the surrounding occupancy with a minimum 1 hour construction. Seal all penetrations and openings to maintain the fire separation	Within 3 Months

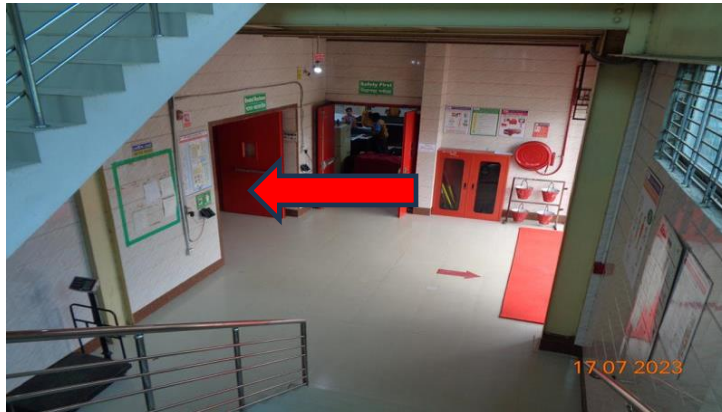
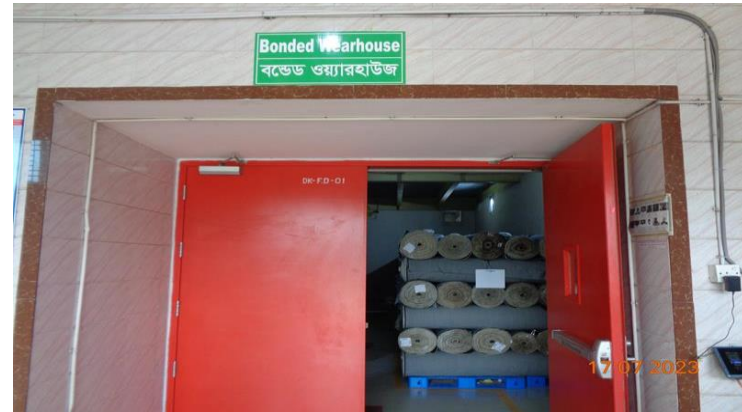
F-3	Fire Rated Construction	Storage rooms at ground floor discharges directly into the exit stair discharge.	Openings from exit enclosure to storage room, generator and hazard spaces shall be provided with a vestibule with fire rated construction and openings. Provide a 1 hr. fire rated door on the exit stair side and a 1-hr. fire rated door on the Store room side. Ensure that the fire rating of the vestibule construction matches that of the exit stair enclosure.	Within 3 Months
-----	-------------------------	--	--	-----------------

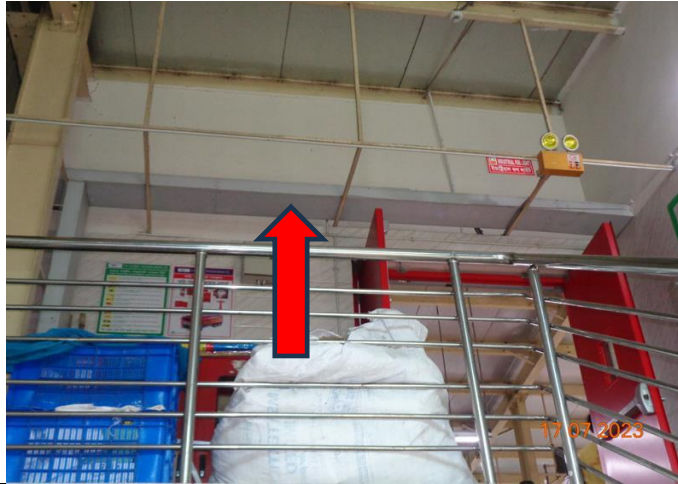
F-4	Fire Rated Construction	Electrical Cable tray has been found in the exit stair. Location: North Exit stair 1st floor.	Remove the Electrical Cable tray from the exit stair enclosure.	Within 3 Months
-----	-------------------------	---	---	-----------------

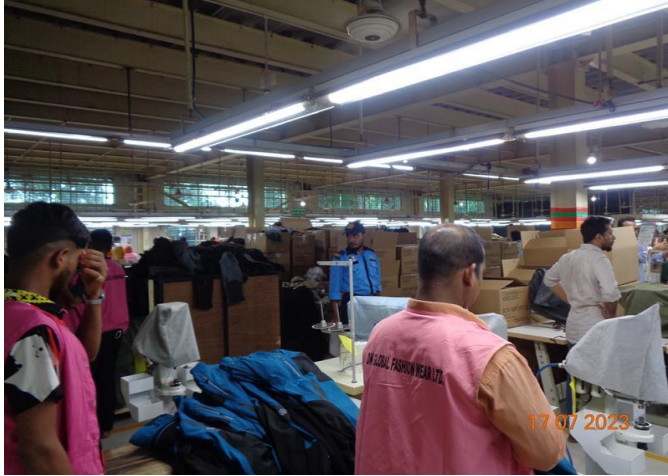
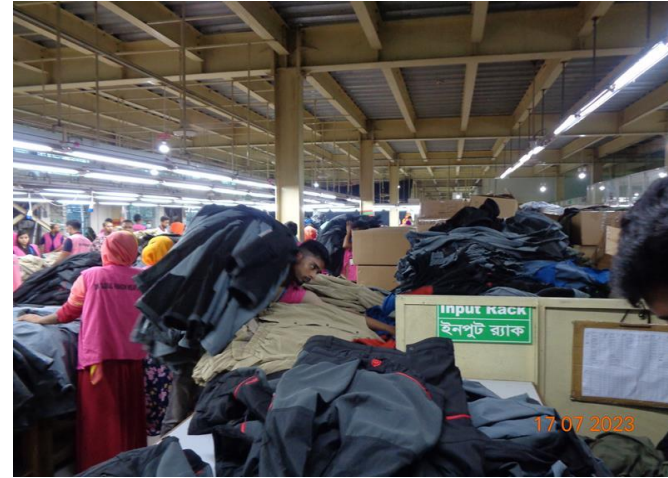
F-5	Fire Rated Construction	<p>Areas used for in-process storage of combustible materials are open to the surrounding occupancy. Location: Ground floor Cutting & Finishing section.</p>	<p>Provide defined storage areas and limit the storage arrangement as follows:-</p> <ol style="list-style-type: none"> 1. General Condition: Maximum height of 2.4m and maximum area of 23m². Separate areas of unenclosed combustible storage by a minimum clear distance of 3m. <li style="text-align: center;">or 3. Enclose the storage area from the surrounding occupancy with a minimum 1 hour construction. Areas shall limit within 10% of the entire floor area. 	Within 3 Months
-----	-------------------------	---	---	-----------------

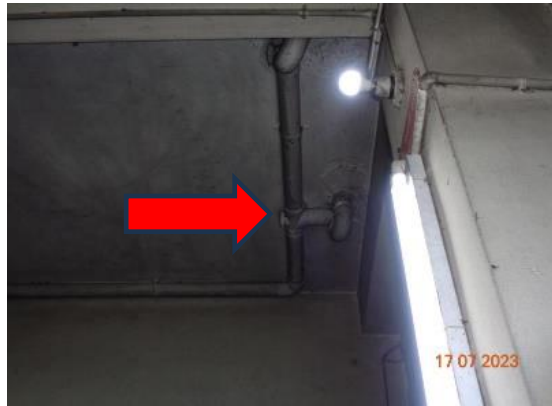
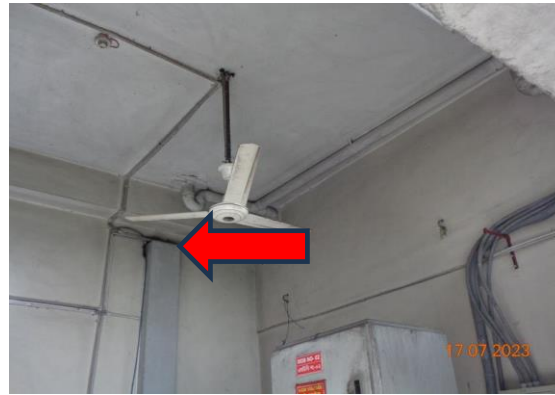
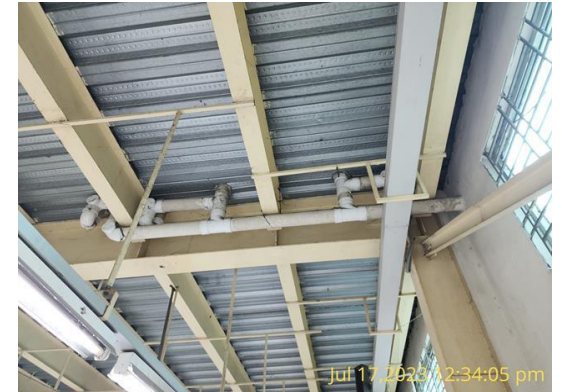
F-6	Fire Rated Construction	<p>Unsealed penetrations and openings are located in the fire rated floor/ceiling assemblies. Followings are the description of openings or penetrations indicating specific locations:</p> <ol style="list-style-type: none"> 1. Passing of BBT/Cable tray through rated walls from Utility building to the production production building. 2. Ground floor to 1st floor opening for Toilet Pipes. 	<p>Penetrations of fire resistiverated assemblies shall be protected with listed through penetration fire stop systemtested in accordance with ASTM E 814 in accordance with RSC technical guideline 4.7</p>	Within 3 Months
-----	-------------------------	---	--	-----------------

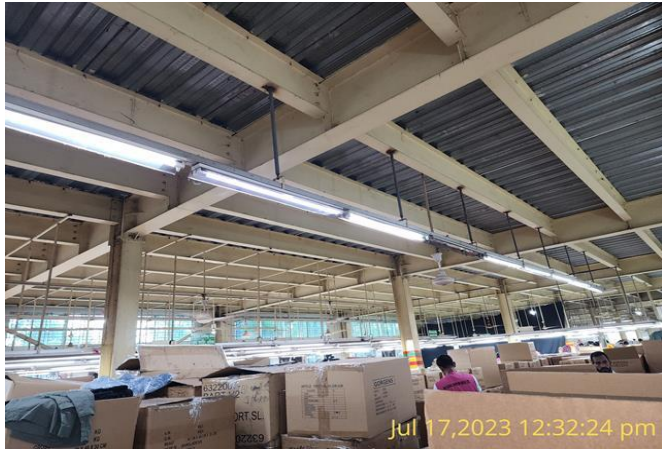
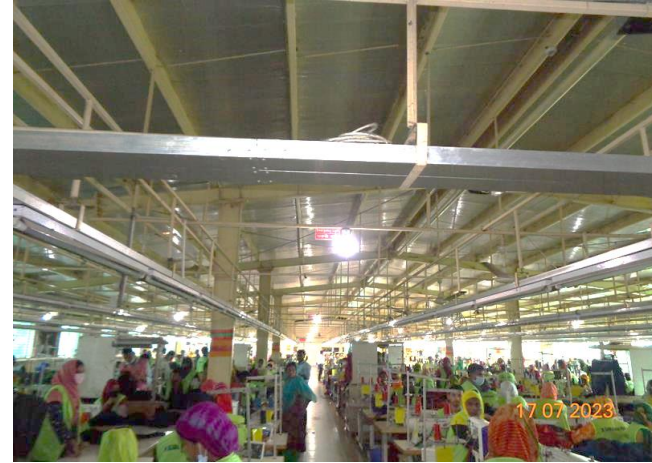
F-7	Fire Rated Construction	The main structural element of the building is constructed by steel element which is non-rated and were found in exposed condition without any fire protection..	Provide fire rating in the structural element (Slab & Beam: 0.5 Hr; Column: 1 Hr) of the building. No fire protection is required where unprotected slab & beam assembly demonstrates a 0.5-hour fire rating. Consult a qualified fire protection engineer to design the rated construction barriers in structural members.	Within 3 Months
-----	-------------------------	--	--	-----------------

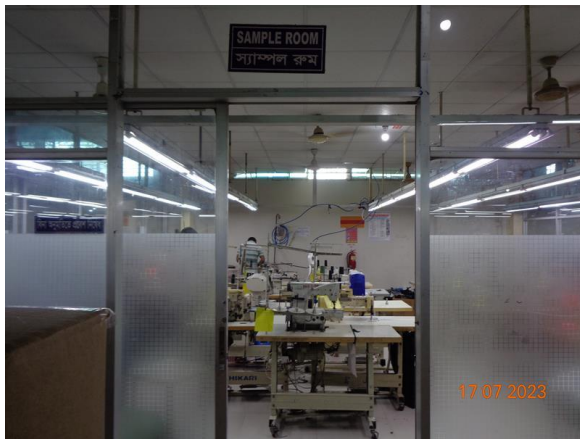
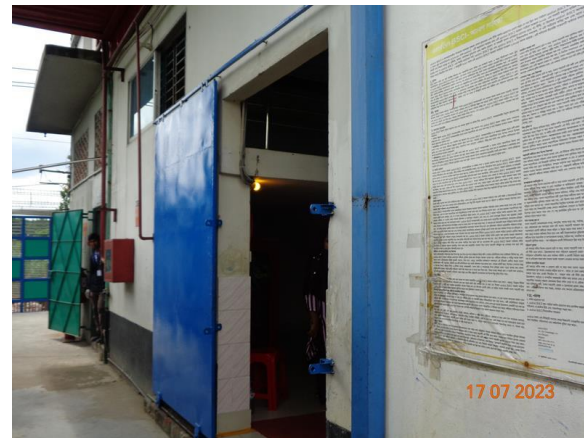
F-10	Means of Egress	Sliding Gates/doors have provided along means of egress	<p>Replace all sliding type doors & gates by the side-hinged swinging type doors in accordance with RSC Standard 6.8.1</p> <p>If locks are required for security reasons, utilize special door locking features complying with NFPA 101.</p>	Within 1 Months
------	-----------------	---	--	-----------------

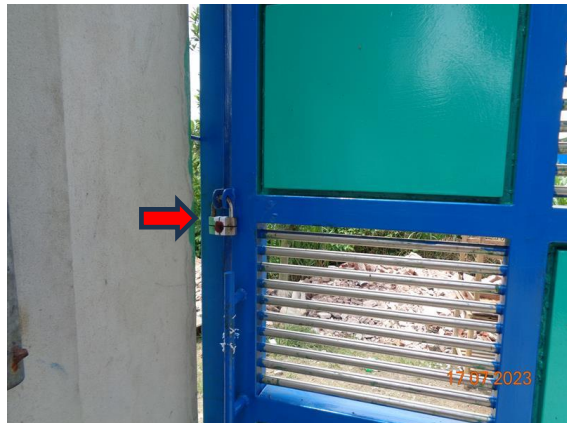
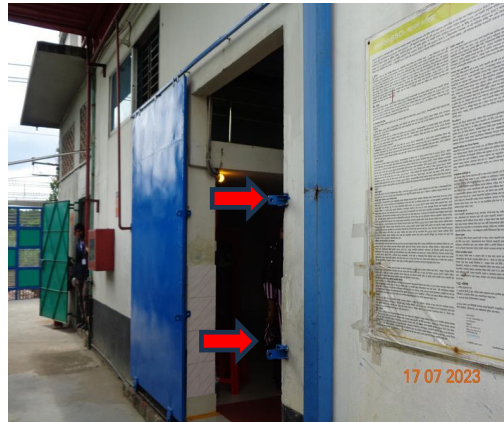
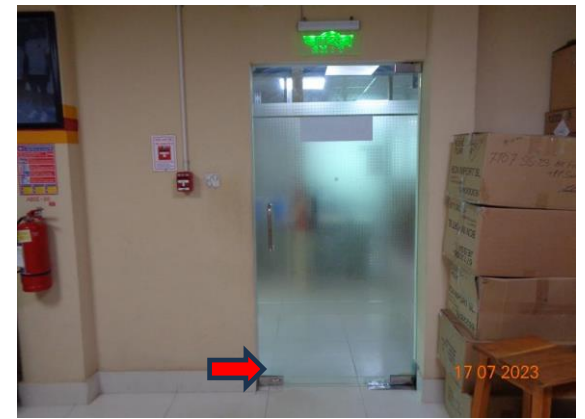
F-11	Means of Egress	Doors along means of egress are provided with non compliant locking system.	<ol style="list-style-type: none"> 1. Remove all non compliant locking features from egress doors. 2. If locks are required for security reasons, utilize special door locking features complying with NFPA 101. 3. Doors may be locked where the latch and lock are disengaged with one motion where the occupant load does not exceed 49 persons. 4. Doors may be provided with locking hardware from the ingress side provided that a panic bar is installed on any door with an occupant load exceeding 49 persons. 	Within 1 Months
------	-----------------	---	---	-----------------

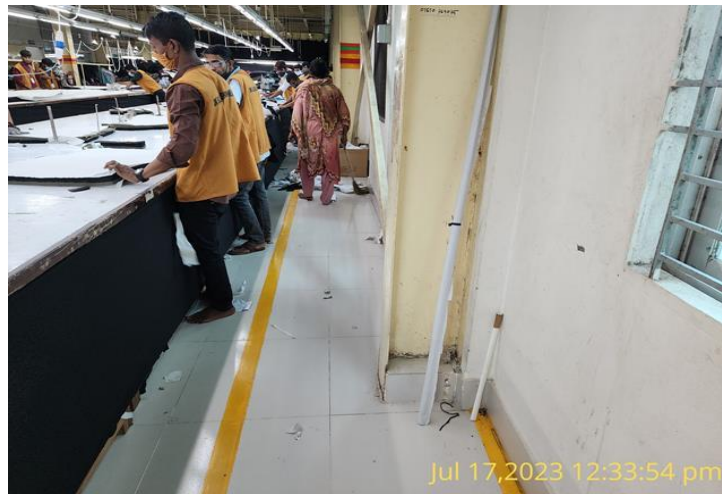
F-12	Means of Egress	Adequate & unobstructed aisles were not provided. Location: Ground floor	Provide minimum and clear aisle width of 36-in where applicable and required.	Within 1 Month
------	-----------------	---	---	----------------

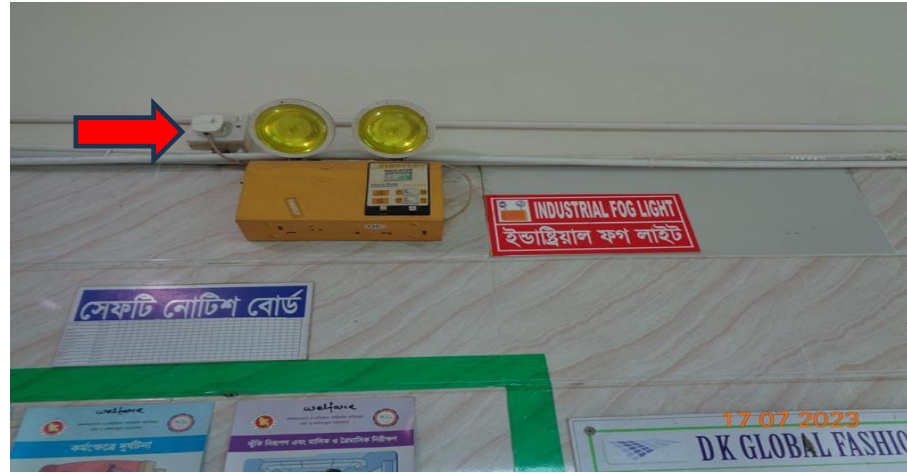
F-15	ITM of Emergency light and Exit Sign	Inspection, testing, and maintenance for the exit sign and emergency lighting system was not in accordance with The RSC Technical standard.	Inspect, test and maintain the exit sign and emergency lighting system in the accordance with The RSC Technical standard. Keep written records on-site.	Within 1 Month
F-16	Egress Lighting	Manual On/Off Switch is provided at emergency lighting.	Remove manual on/off switches from emergency lighting / exit signage units to prevent them from being switched off.	Within 1 Month

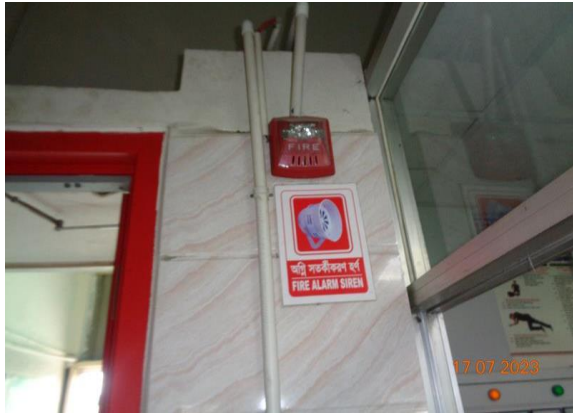
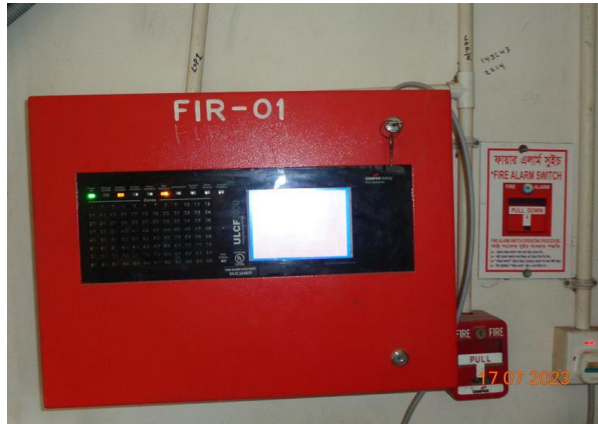
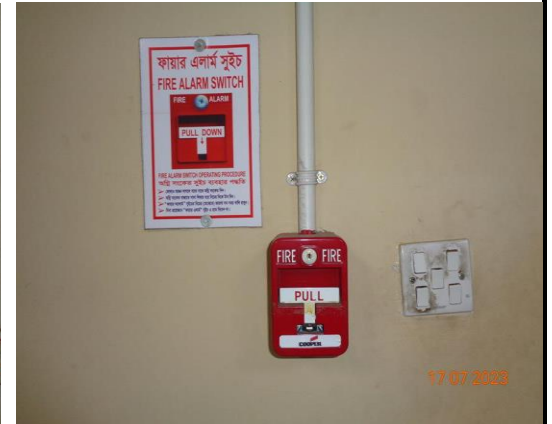
F-17	Fire Alarm and Detection System (FADS)	Fire alarm & detection system installation requires detailed review to confirm compliance with NFPA 72 and RSC Technical Guidelines (Standards).	Submit as-built drawings, testing records, equipment certification and other relevant documentation to the RSC for review and approval; modification (if required) shall have to done as per the reviewed design and standard.	Design Review within 2 months and installation within 4 months.
------	--	--	--	---
